## TRACTOR SERVICE INFO

TB1666

### Part Nr. 230 0009 11 – 300/280mm TGU6

**SDF DX110A**  
**DX85A**  
**DX90**

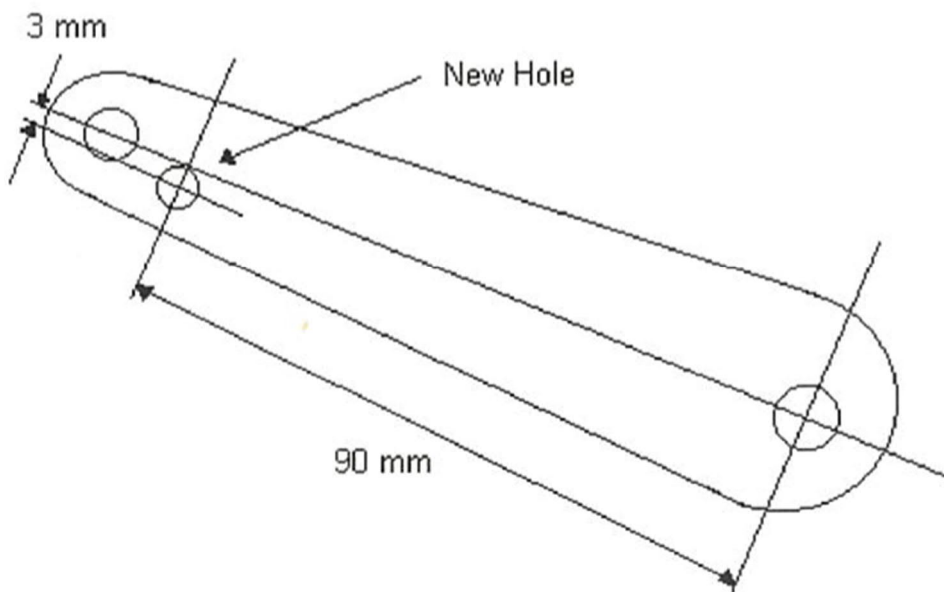
If you replace the earlier type clutch with the later model, then it is necessary to modify the release bearing movement sufficiently to ensure full disengagement. Failure to make this modification will cause severe clutch drag.

- Drill a new hole in the cross-shaft bellcrank arm ( dia 12.3mm ) in the position shown below.
- The clutch pedal travel must be increased from 180mm to 206mm by modifying the stop screw ( Note: it may be necessary to shorten and re-thread the pull rod accordingly ).

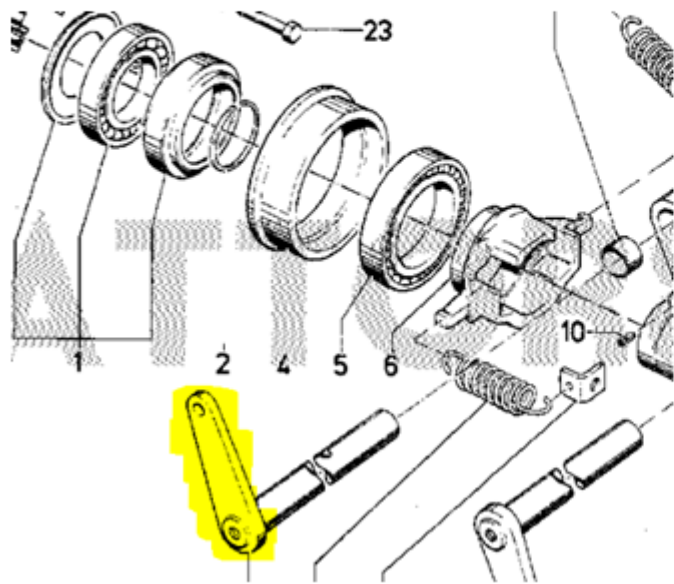
Der Hintergrund dazu ist, dass die ersten DX für die Fahrscheibe keine Belagfederung hatten. Dadurch war natürlich bedingt durch den Sinterbelag, das Anfahrverhalten sehr gewöhnungsbedürftig. Das wurde geändert und eine Belagfederung eingebaut. Mit der Belagfederung wird aber mehr Ausrückweg benötigt. Diesen zusätzlichen Ausrückweg bekommt man durch die zurückgesetzte Bohrung. Die Bohrung wird in den angeschweißten Hebel der Ausrückwelle gebohrt. Siehe Bild.
