TB2001

## TRACTOR SERVICE INFO

Part Nr. 333 0170 11 – 330mm TDCA – 17 Spline

STEYR – M9078, M9083, M9086, M9094

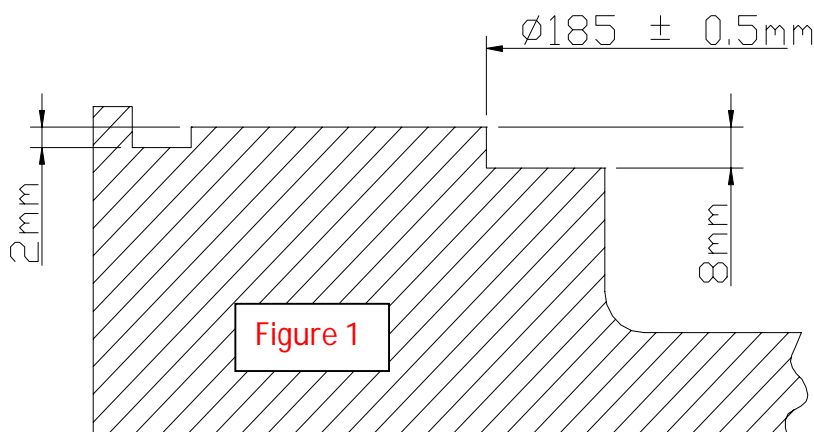
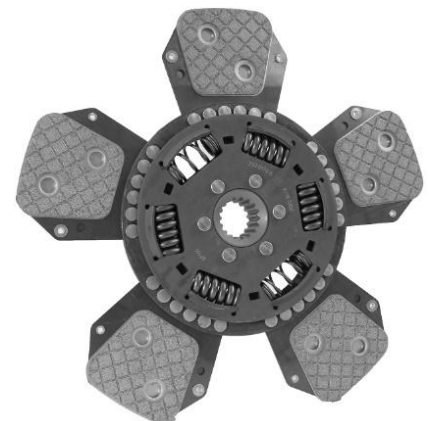
Re-machine the flywheel inner recess to a diameter of  $185 \pm 0.5$  mm and a depth of 8 mm to avoid rivet contacting flywheel.

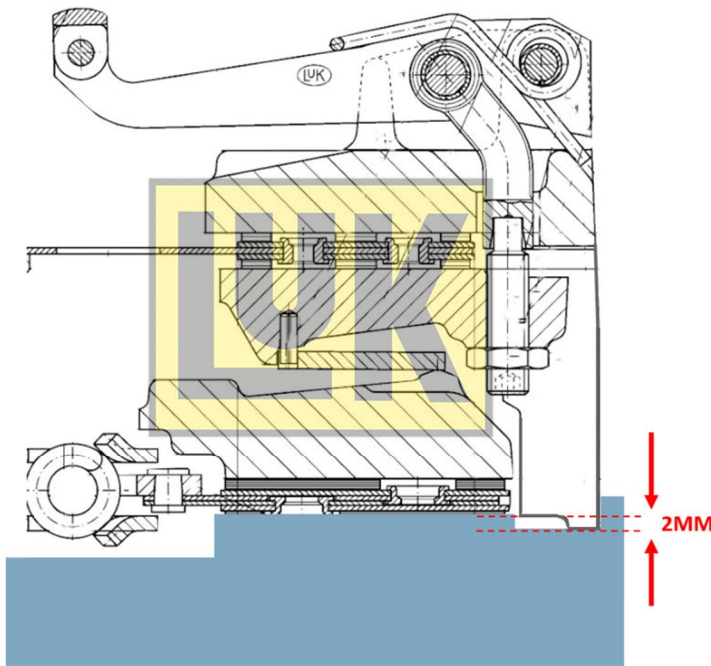
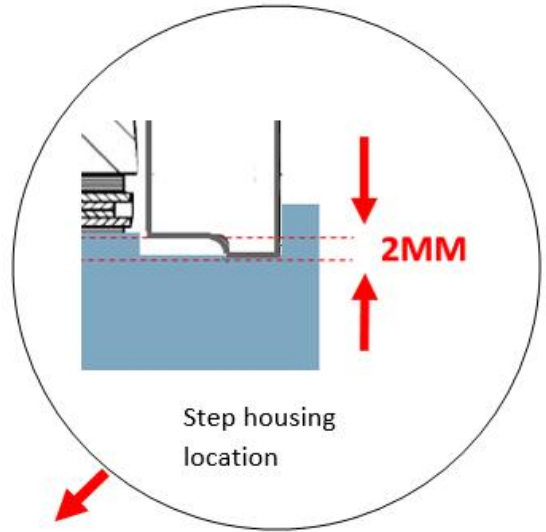
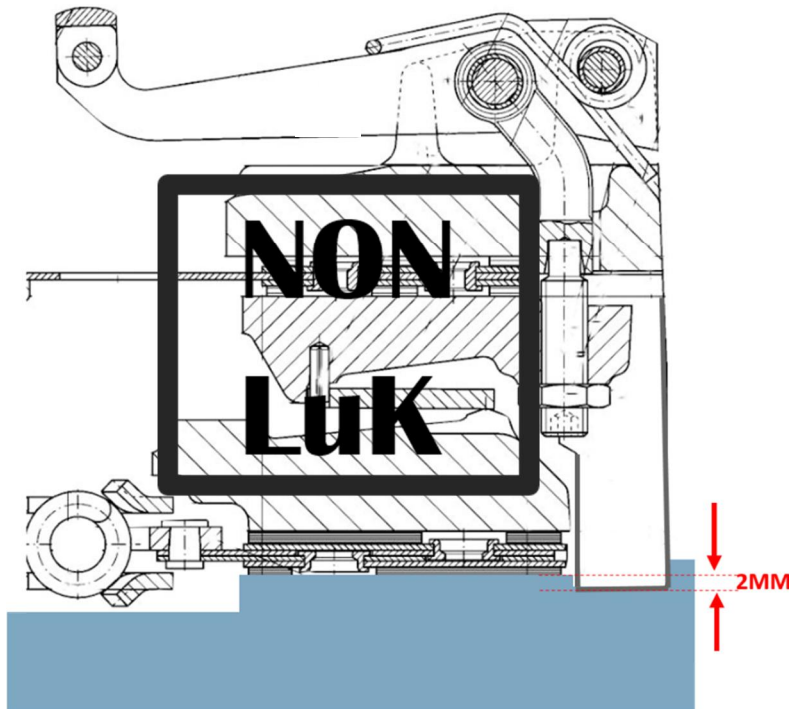
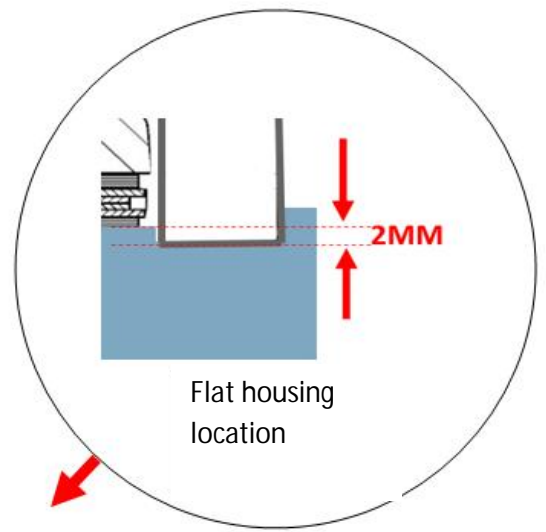
**Clutch housing location using flywheel step of 2mm. See Figure 1**
